July 22, 1994

Utility International
Aftermarket Parts Division

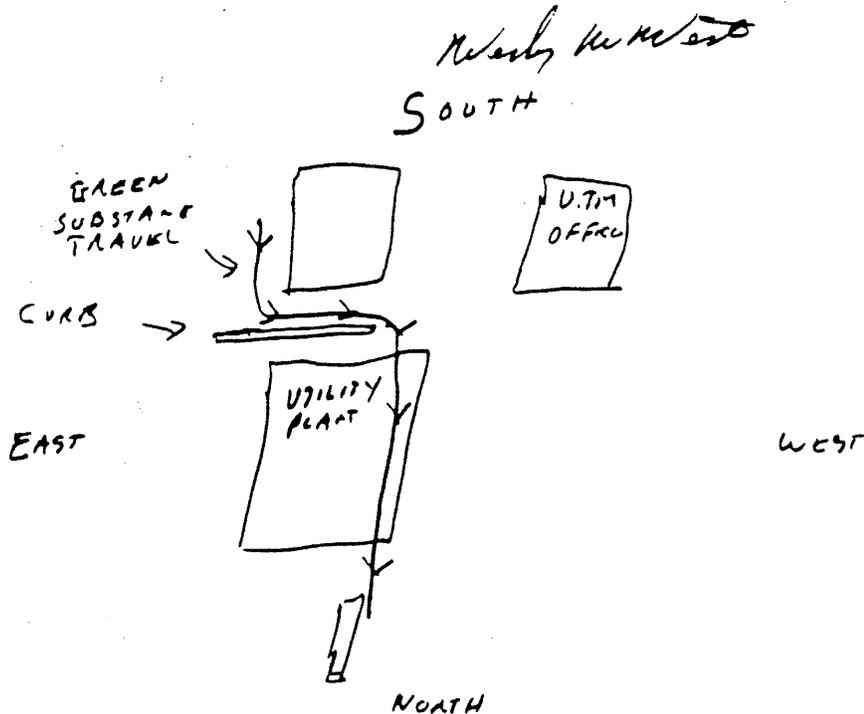
ON FEB 4 AT APROX 12:30 PM. I
NOTICED IN THE RUN OFF WATER
A GREEN SUBSTANCE. I FOLLOWED IT
TO THE SOUTH END OF OUR PLANT.
THE WATER WITH GREEN IN IT WAS
COMING FROM THE DRIVEWAY OF
THE PLANT TO THE SOUTH ALONG
THE CURB. FOLLOWED IT TO THE
EAST AND IT WAS COMING FROM
THE SOUTH EAST SIDE OF THE
PLANT TO THE SOUTH OF OURS.
