**PROPERTY CONDITION SURVEY REPORT**

**THE PLAZA AT PUENTE HILLS**

**Burnham Portfolio**

Marx/Okubo Job No. 6170

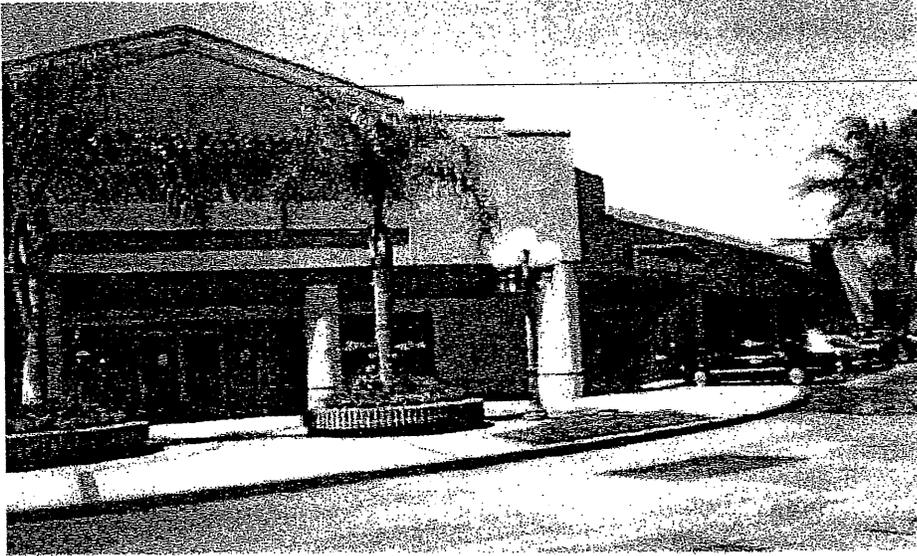
Photograph #1

Typical shops elevation.

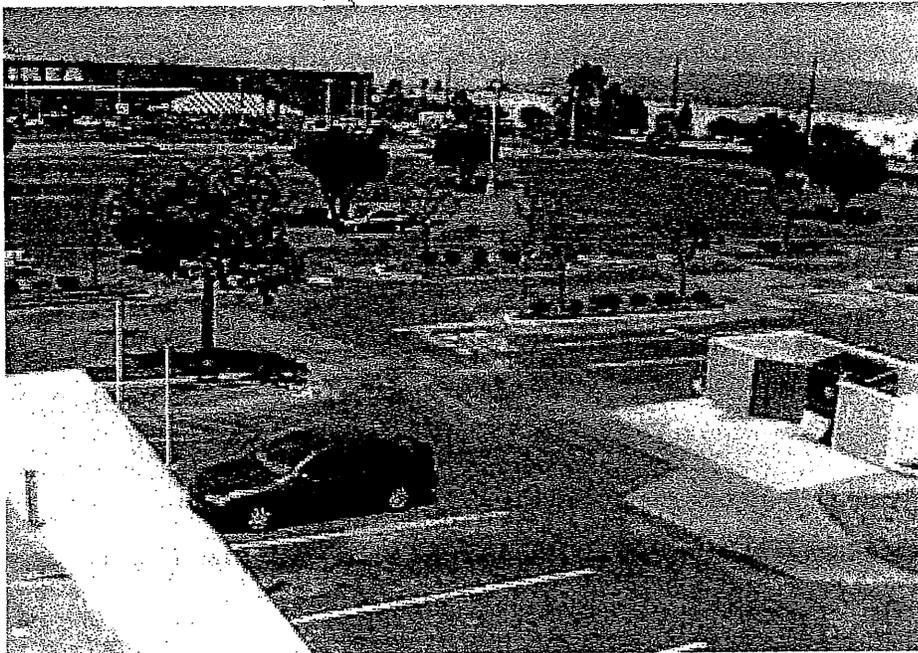
Photograph #2

View of parking area from Building G.

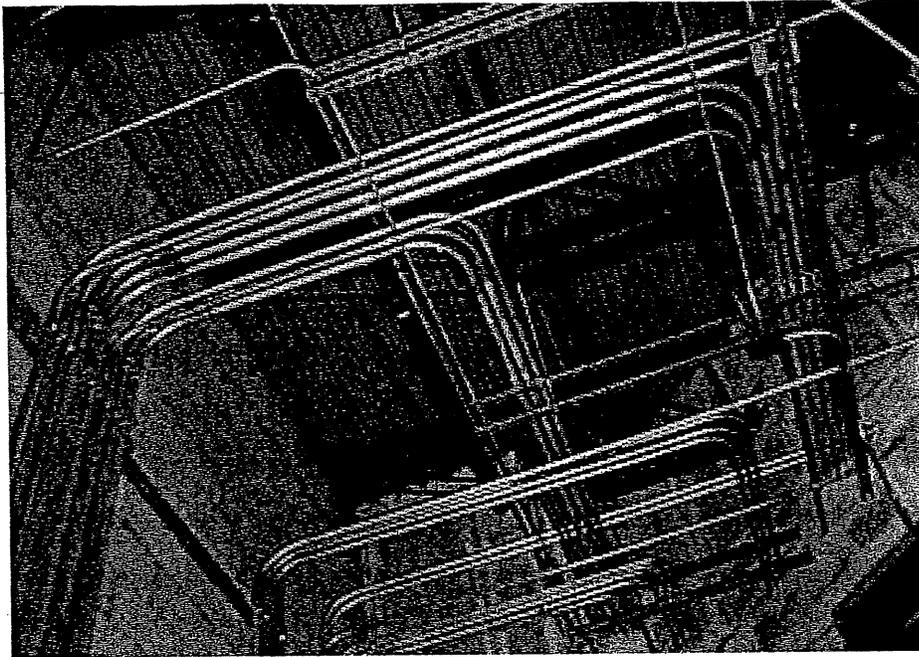
Photograph #5

Roof structure of  
Building H.

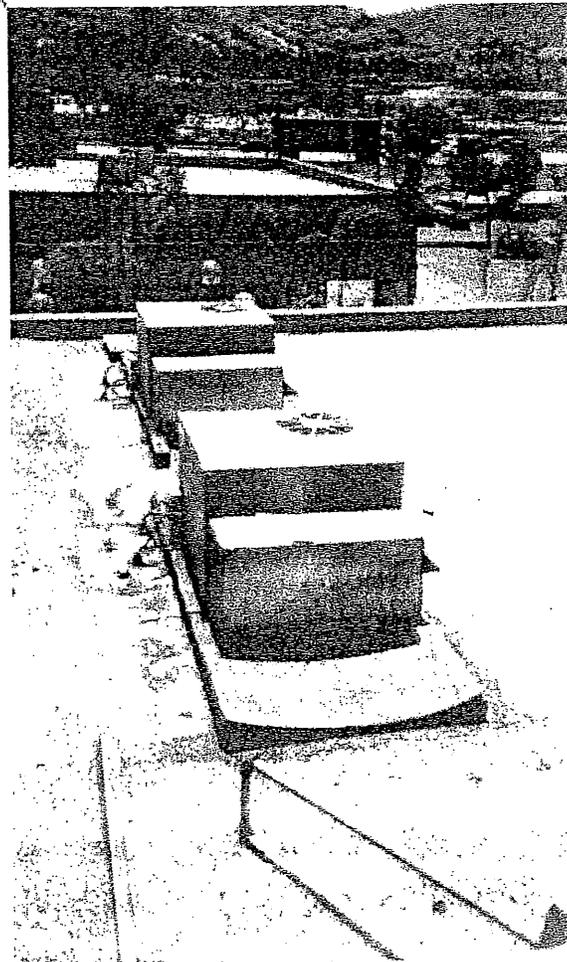
Photograph #6

View of rooftop  
equipment at  
Building H.

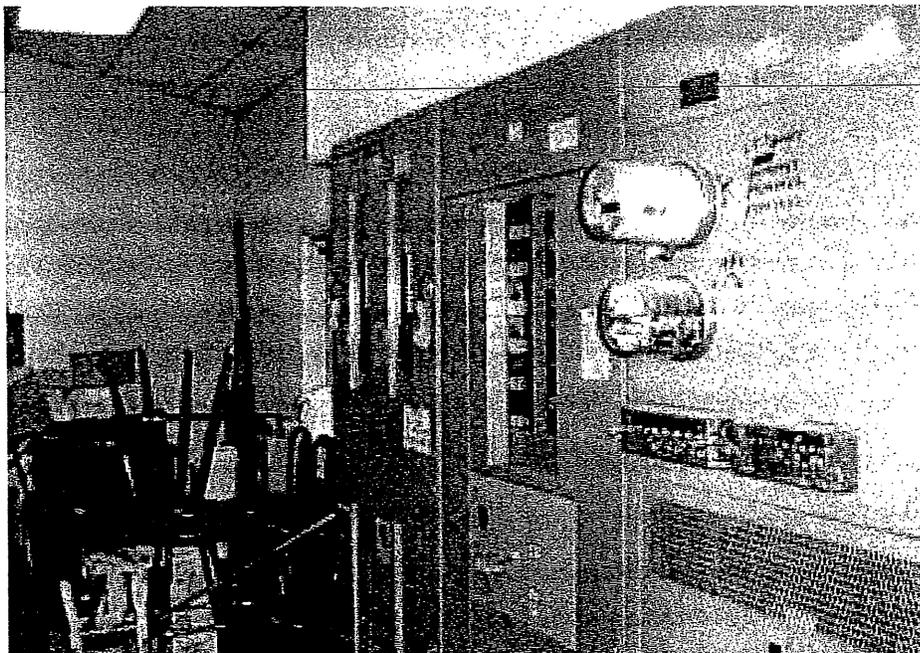
Photograph #7

Electric panel at  
Building E.

15.	Perform infrared electrical survey.	10,500	10,500
	<i>Subtotal MEP</i>	\$10,500	\$ 670,500
	<b>Accessibility</b>		
16.	Curb ramps needed at some areas to connect buildings	4,000

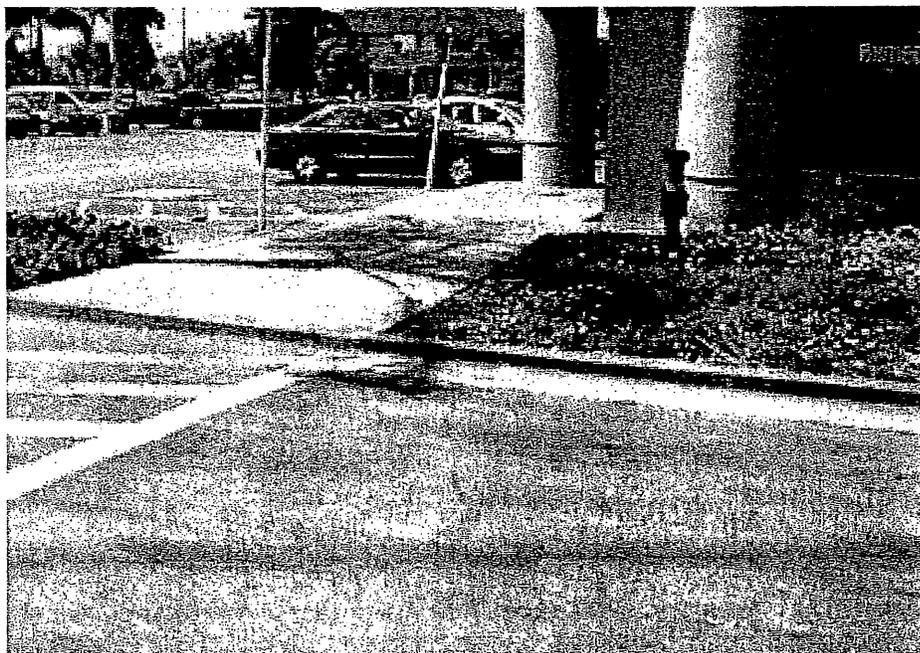
Photograph #8

Ramp needed at  
Building F.

- Add curb ramps to connect buildings.
- Add parking stall signage.

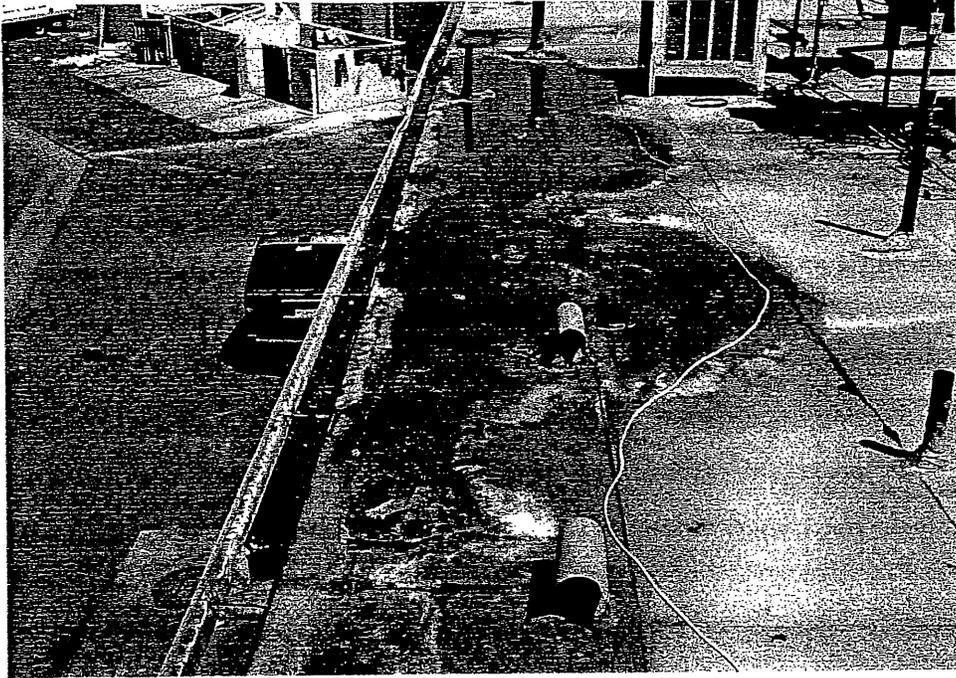
Water ponds at rear of Y building.

50 new penetrations	\$ 2,500.00
Reinforce roof at rear of Y building	\$ 1,500.00
Repair roof on S building	\$ 500.00
Replace missing asphalt shingles	\$ 750.00
Miscellaneous repairs to sleepers, etc.	\$ 1,000.00

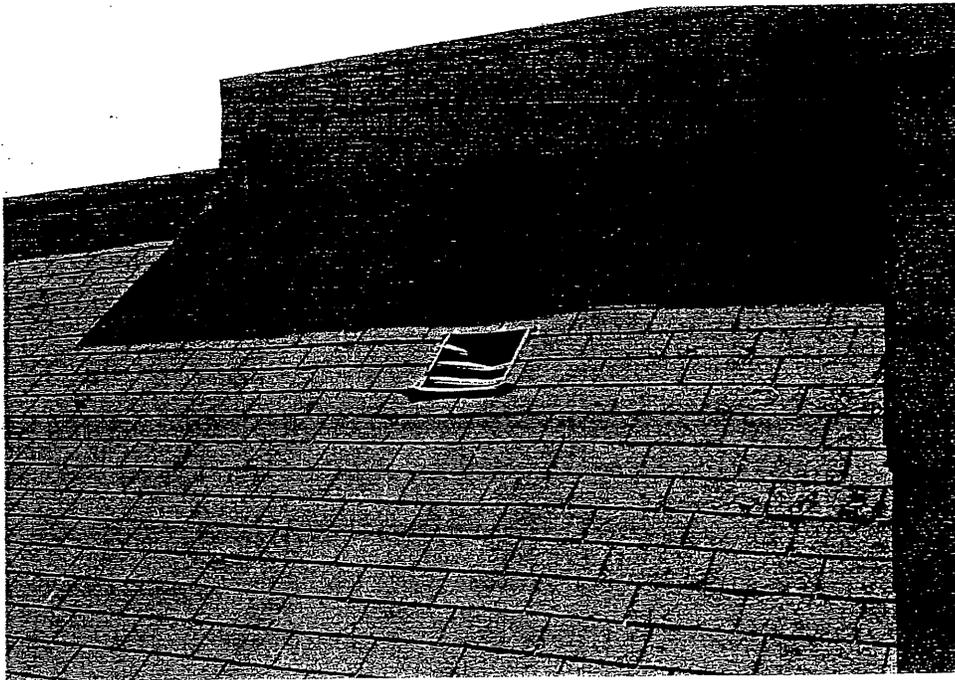
It does not appear that any of the roofs have been maintained in some time. Many tenant additions have placed new penetrations throughout the project, especially on the Buildings S & Y. Numerous attic/parapet vents are missing, allowing birds and vermin into the attic space (behind the mansards). Missing asphalt shingles, at the parapets, need to be addressed.

Typical asphalt shingle detail. Note damaged wall vent.

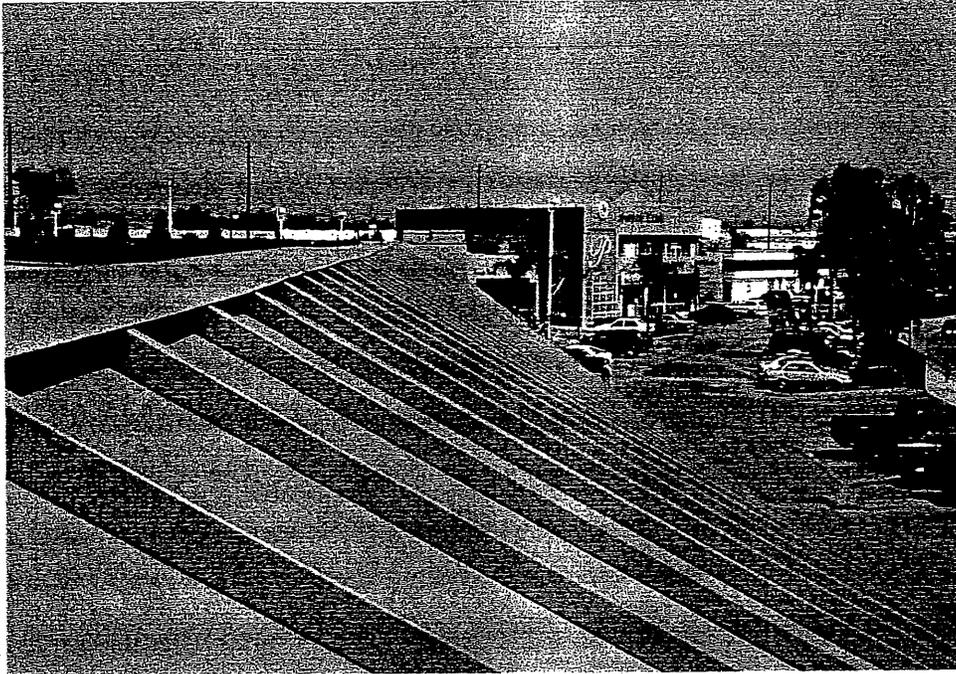
Typical metal mansard.

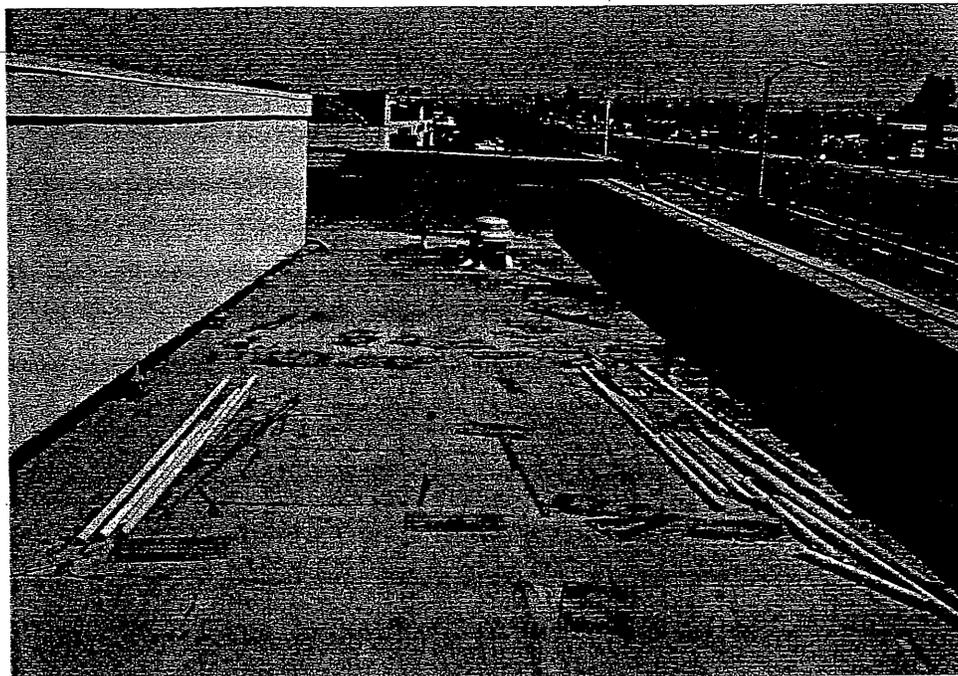
Construction debris and patching on The Hop roof.

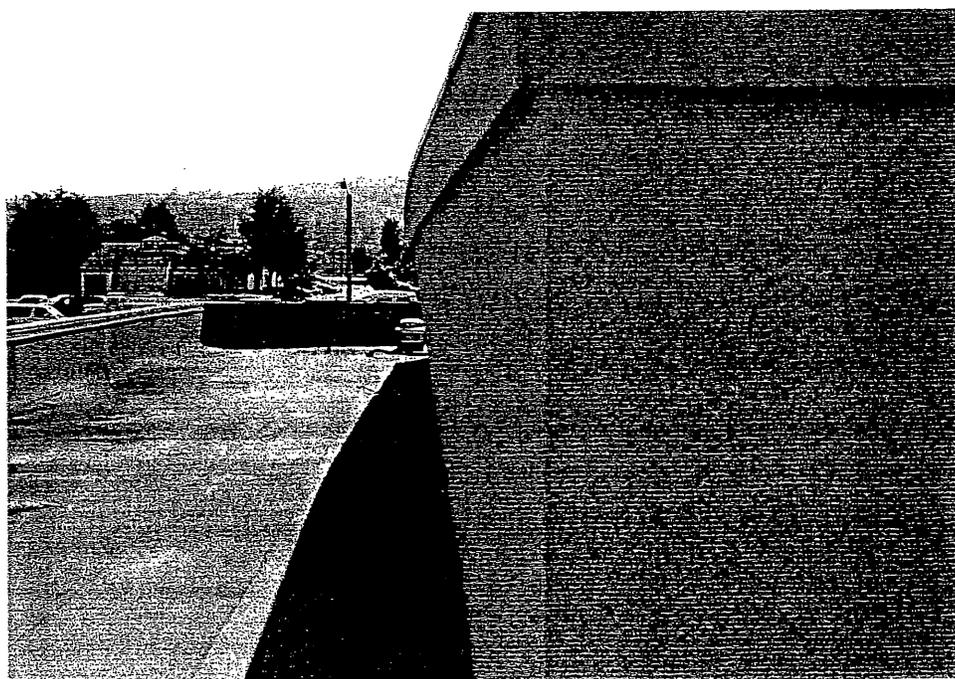
The sight screen on The Hop is bowing and will need additional support. Self-flashing skylights on the Ikea store tend to leak, however, most leak sources appeared to be from maintenance items. Throughout the complex, especially over the smaller shop areas are many sleepers, penetrations and new installations that need to be repaired or permanently flashed. Metal joints, at the gravel stops, will need to be reinforced during maintenance.

Sight screen is bowing.

7.	Paint buildings		125,000
8.	Exterior stucco repairs.	10,000	25,000
9.	Repair equipment screen at "The Hop."	7,000	
	<i>Subtotal Building</i>	\$17,000	\$1,650,000
	<b>Structure</b>

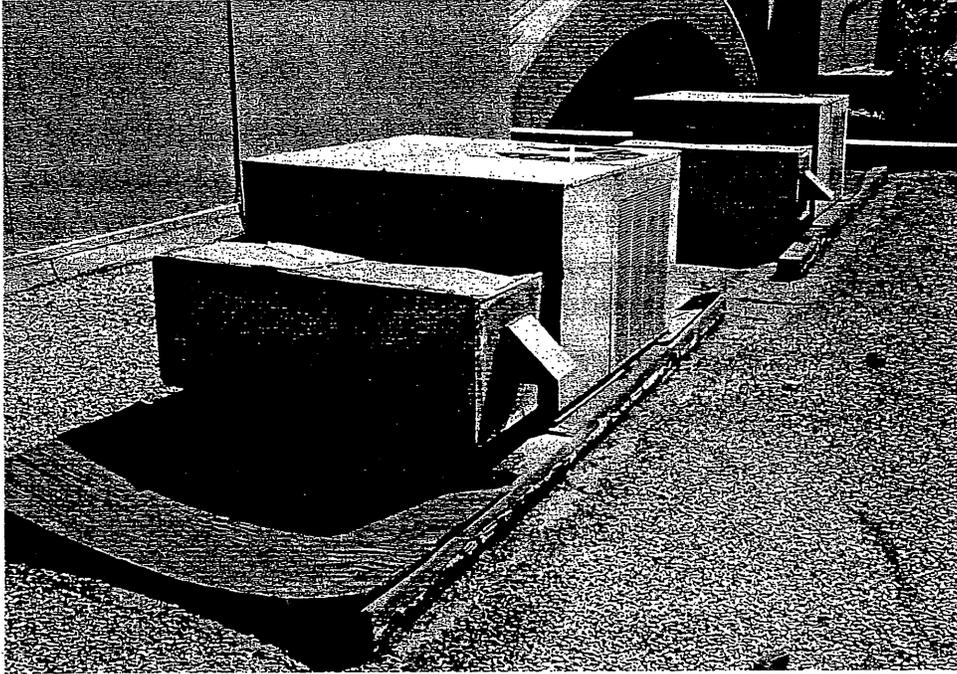
Poor sleeper details on movie theater.

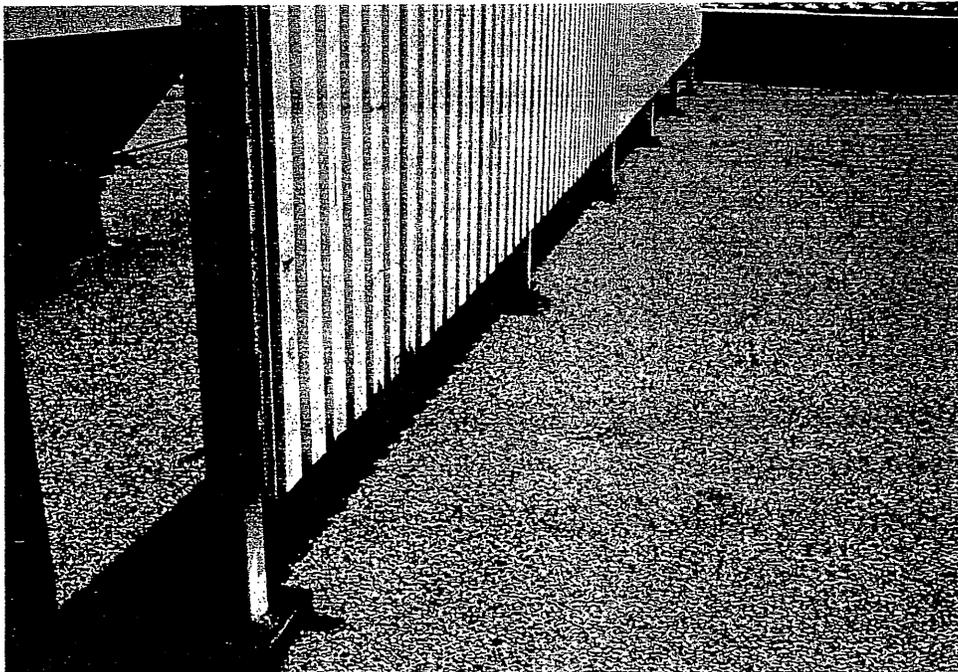
All sight screen pitch pans need to be filled and crowned.

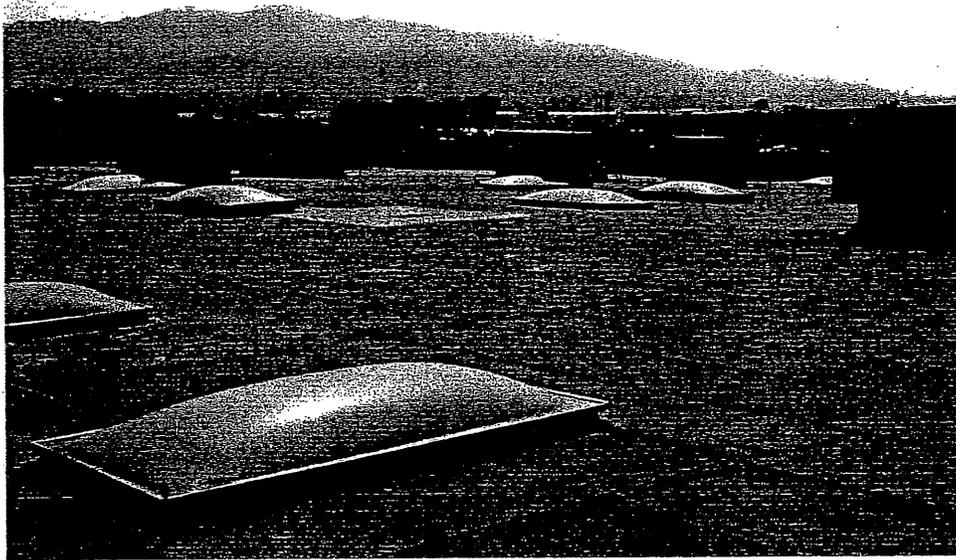
Skylights have been a leaking source at the Ikea store.

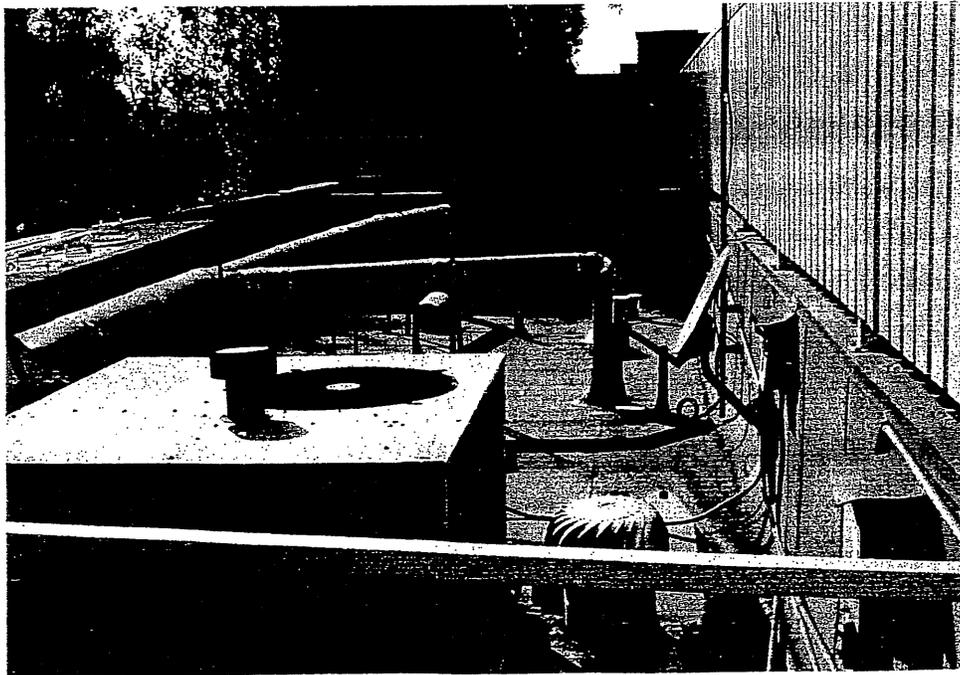
Frisco's roof was recently replaced.
