PHASE I ENVIRONMENTAL SITE ASSESSMENT UPDATE

**GREATER CALIFORNIA  
INDUSTRIAL PORTFOLIO**

**111 NORTH HUDSON  
CITY OF INDUSTRY,  
CALIFORNIA**

SUBJECT: **LETTER REPORT  
PHASE I ENVIRONMENTAL SITE ASSESSMENT UPDATE**

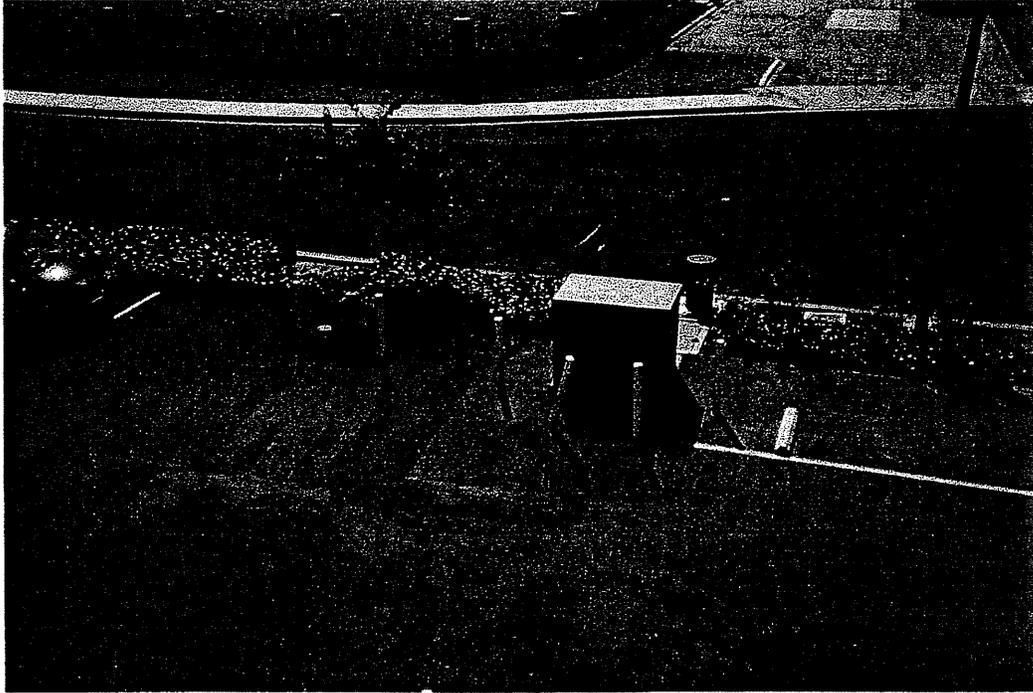
1

One pad-mounted electrical transformer was observed on the east side of the subject property. The transformer is owned and operated by the Southern California Edison (SCE). No stains were observed on the concrete pads, or on the adjacent soil or grass, during the site reconnaissance. According to SCE's Environmental Department,<sup>5</sup> based upon the recent construction date of the building, it is unlikely that PCB-containing insulating oils exist within SCE transformers that were installed.

1. View of transformer on east side of lot at 111 Hudson Avenue.

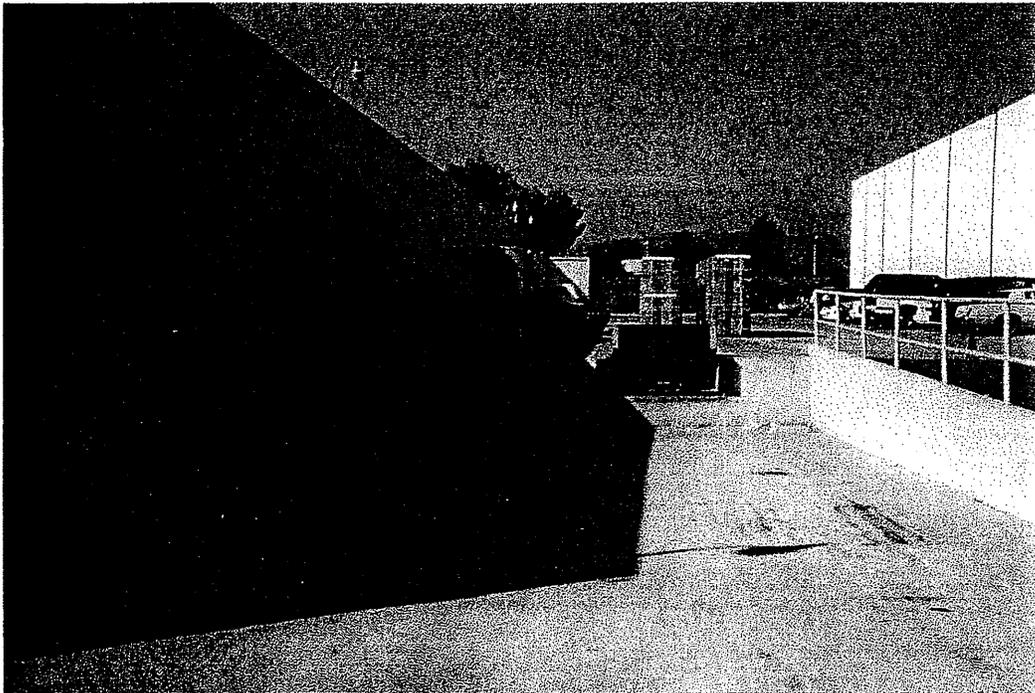
2

2. Loading dock at 111 Hudson Avenue. Royal Computer west side of building

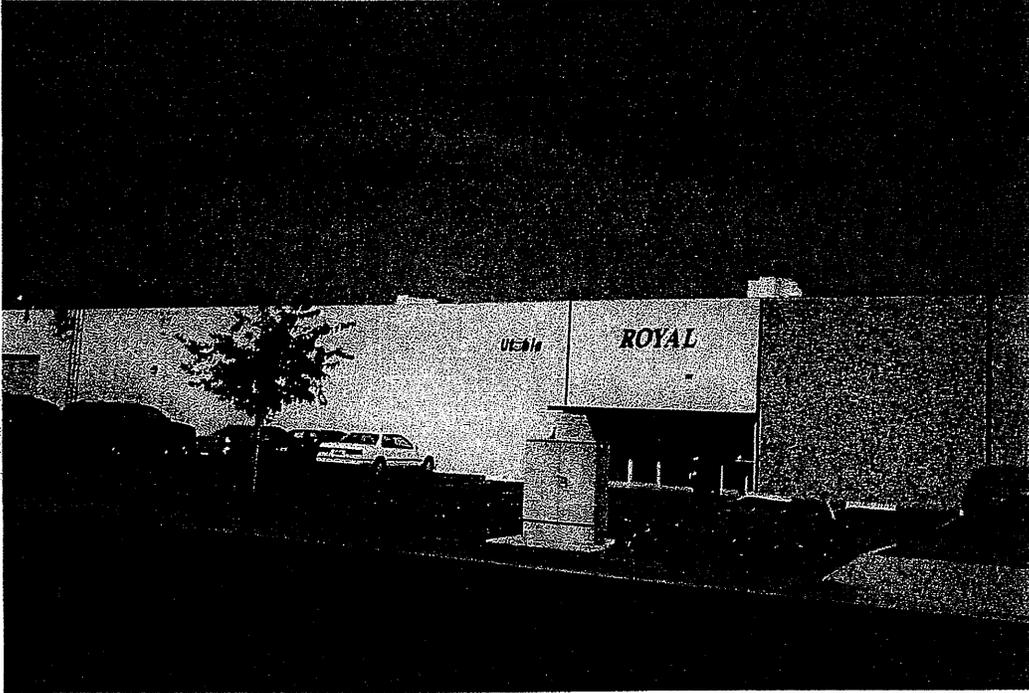
3

3. 111 Hudson Avenue. Royal Computer east side of building.

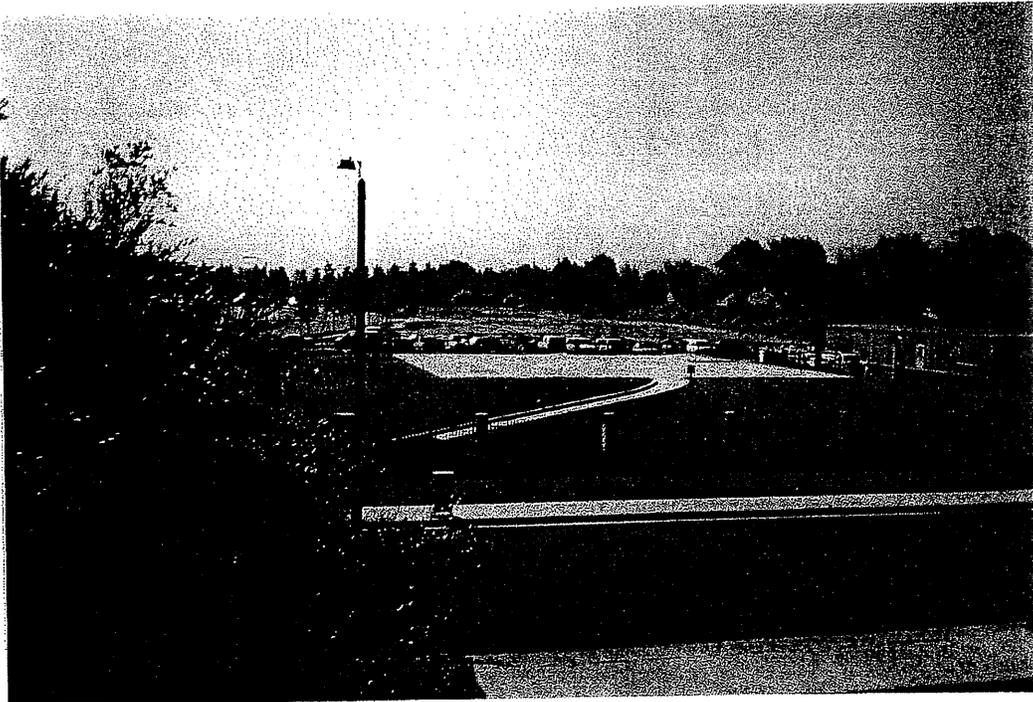
4

A heliport pad for the Los Angeles County Sheriff Department presently occupies the adjacent property to the east. According to the review of available regulatory and government databases and records, no hazardous waste violations, USTs or leaking USTs (LUSTs) are listed for the heliport pad.

4. View of east of 111 Hudson Avenue. Helipad for Los Angeles County Sheriff.

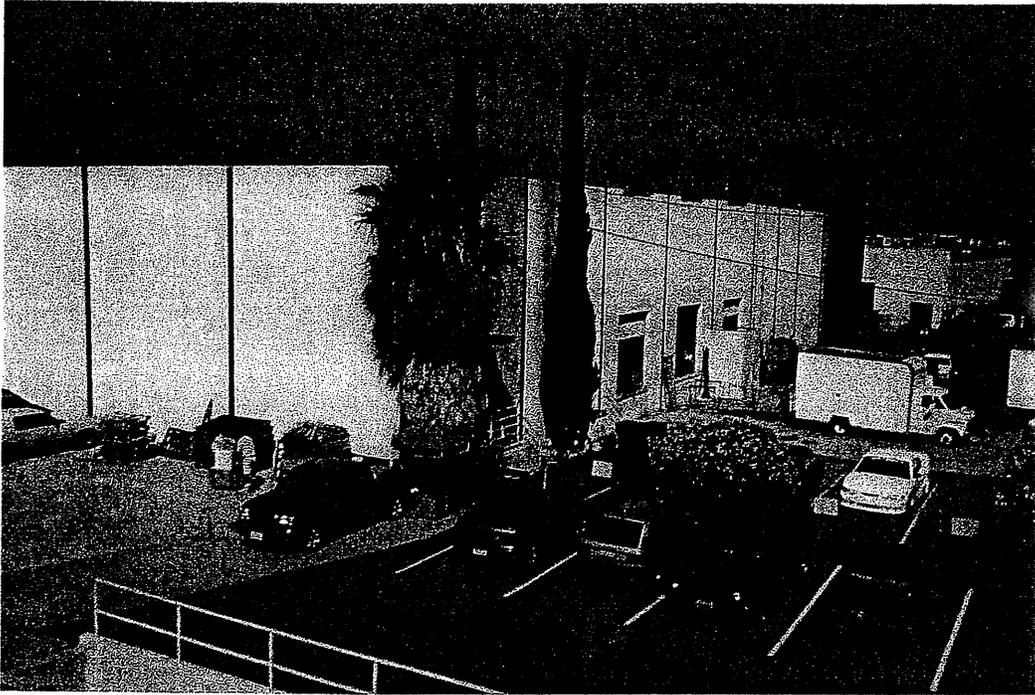
5

Adjacent to the west is a warehouse. According to the review of available regulatory and government databases and records, no hazardous waste violations, industrial waste discharge permit, or LUSTs are listed for the commercial buildings.

5. View west from 111 Hudson Avenue.
