**HAZARDOUS MATERIALS REMOVAL WORK PLAN
BUILDING DEMOLITION
14700 NELSON AVENUE (FRONT)
CITY OF INDUSTRY, CALIFORNIA**

December 9, 2011
Project No. 100213003

Subject: Hazardous Materials Removal Work Plan
Building Demolition at
14700 Nelson Avenue (Front)
City of Industry, California

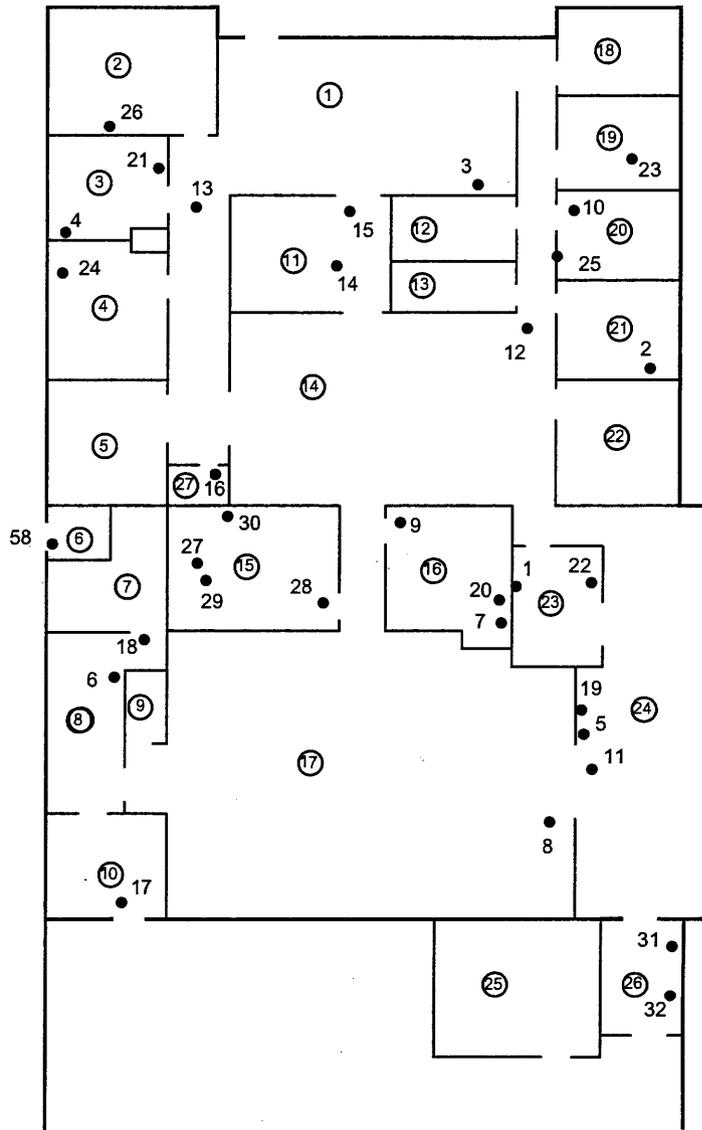
3

Notes:
 HA = Homogeneous Area (see Table 1)
 ND = Not Detected
 Building, room, and sample locations are shown in Figures 2, 3, & 4.

- ① ROOM NUMBER
- 2 SAMPLE LOCATION

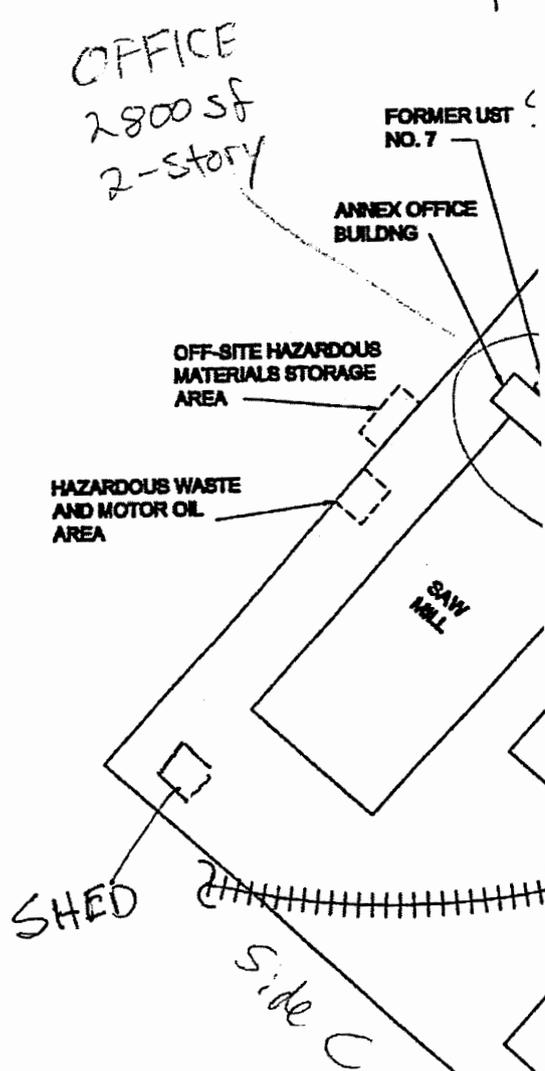
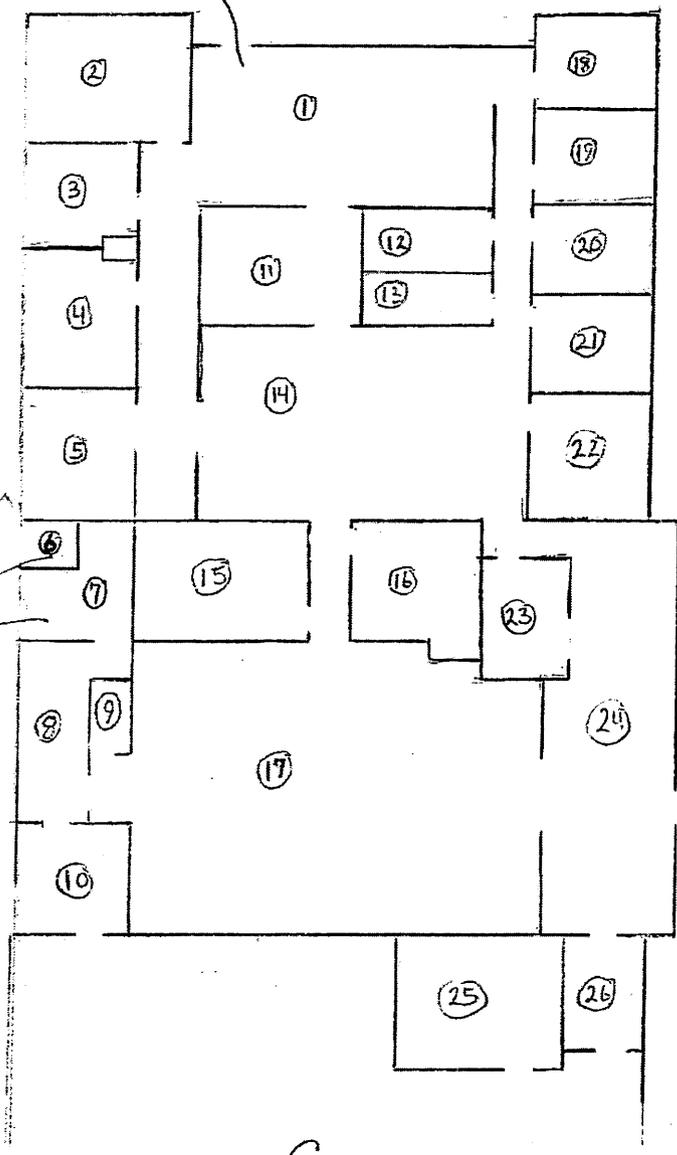
APPENDIX B
LEAD TESTING MAP

- UST UNDERGROUND STORAGE TANK
- AST ABOVEGROUND STORAGE TANK
- [Dashed Box] APPROXIMATE LOCATION OF ENVIRONMENTAL CONCERN
- [Cross-hatch] ON-SITE RAILROAD SPUR
- LBP Lead-Based Paint, positive XRF Reading
- Sides A-D Lead testing orientation
