August 30, 2010
Project No. 100148003

Subject: Miscellaneous Hazardous Building Materials Survey
Building Demolition at
111 North Hudson Avenue
City of Industry, California

ASBESTOS SURVEY
111 NORTH HUDSON AVENUE
CITY OF INDUSTRY, CALIFORNIA

Subject: Asbestos Survey
111 North Hudson Avenue
City of Industry, California

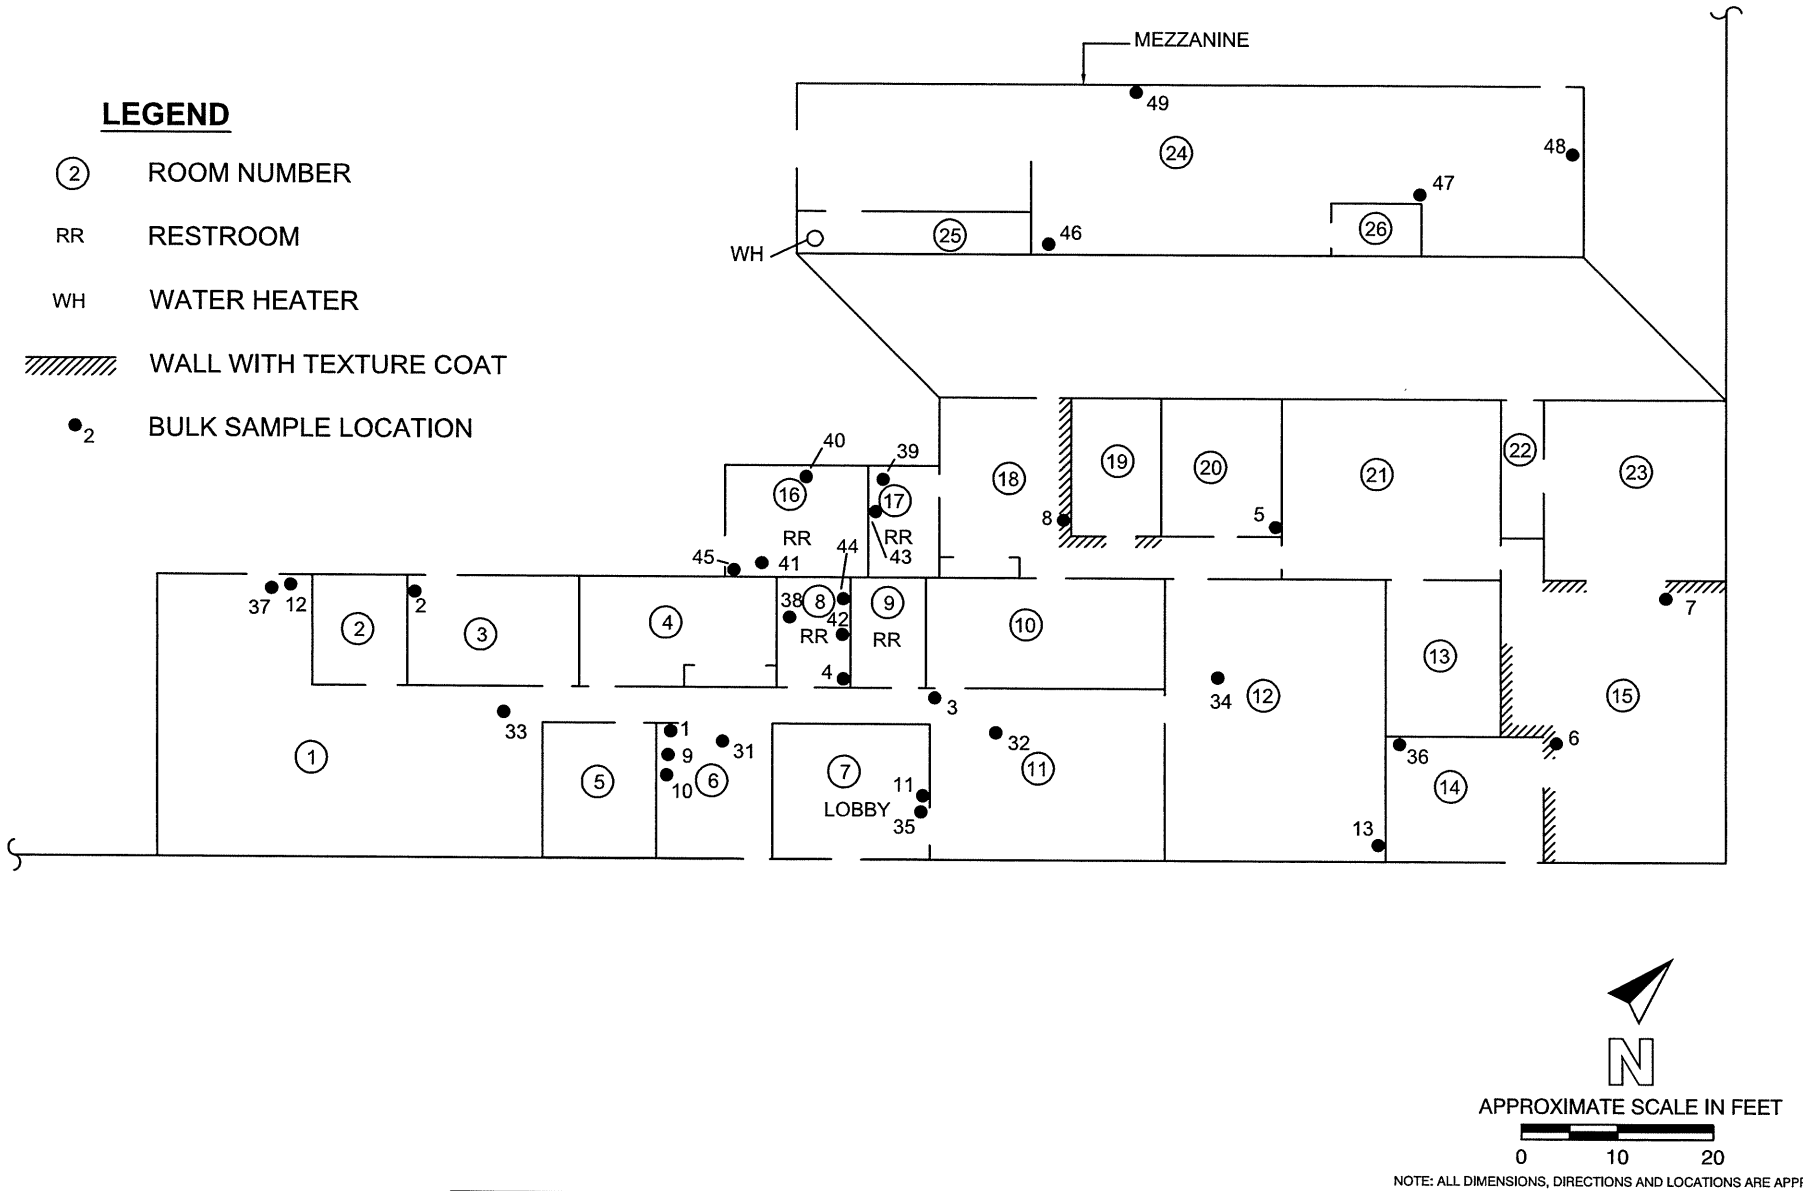
ARDENT ENVIRONMENTAL GROUP, INC.	PROJECT NO. 100148003	**BULK SAMPLE LOCATIONS - OFFICE AREA**	FIGURE
	DATE 8/10	111 NORTH HUDSON AVENUE CITY OF INDUSTRY, CALIFORNIA	3

A listing of all homogeneous areas (HAs) of suspect ACMs is provided in Table 1. A total of 49 bulk samples were collected from the site buildings. Bulk sample locations are shown in Figures 3 and 4. In addition, two large rolling fire doors in the warehouse area of the site building were inspected for possible ACMs. The fire doors were found to be constructed of wood core and sheet metal exterior. Therefore, samples were not collected of the fire door materials.

Sample, room number and roof section locations are shown in Figures 3 & 4.
