PHASE I ENVIRONMENTAL
SITE ASSESSMENT REPORT
111 N. HUDSON AVENUE
CITY OF INDUSTRY, CALIFORNIA 91744

Fluor Daniel GTI Project: 011100575

February 14, 1997

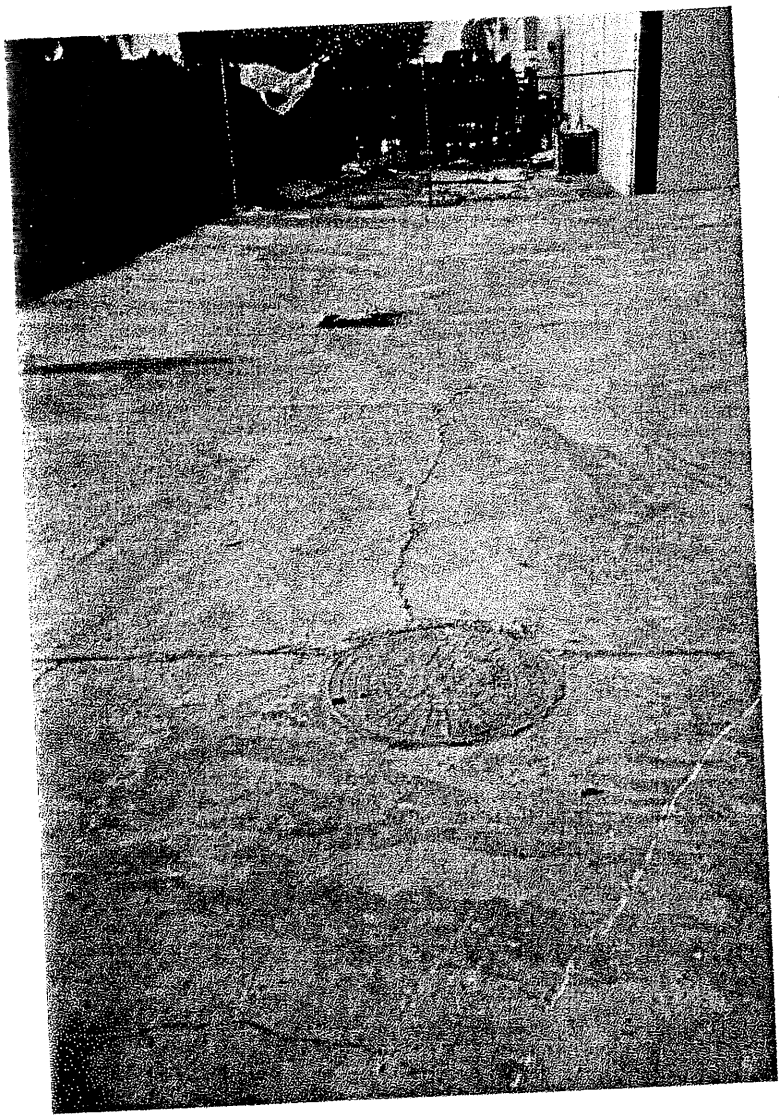
Description: Manhole cover and an example of several stormwater drains on the property. Photo taken in the northwest corner of the site.

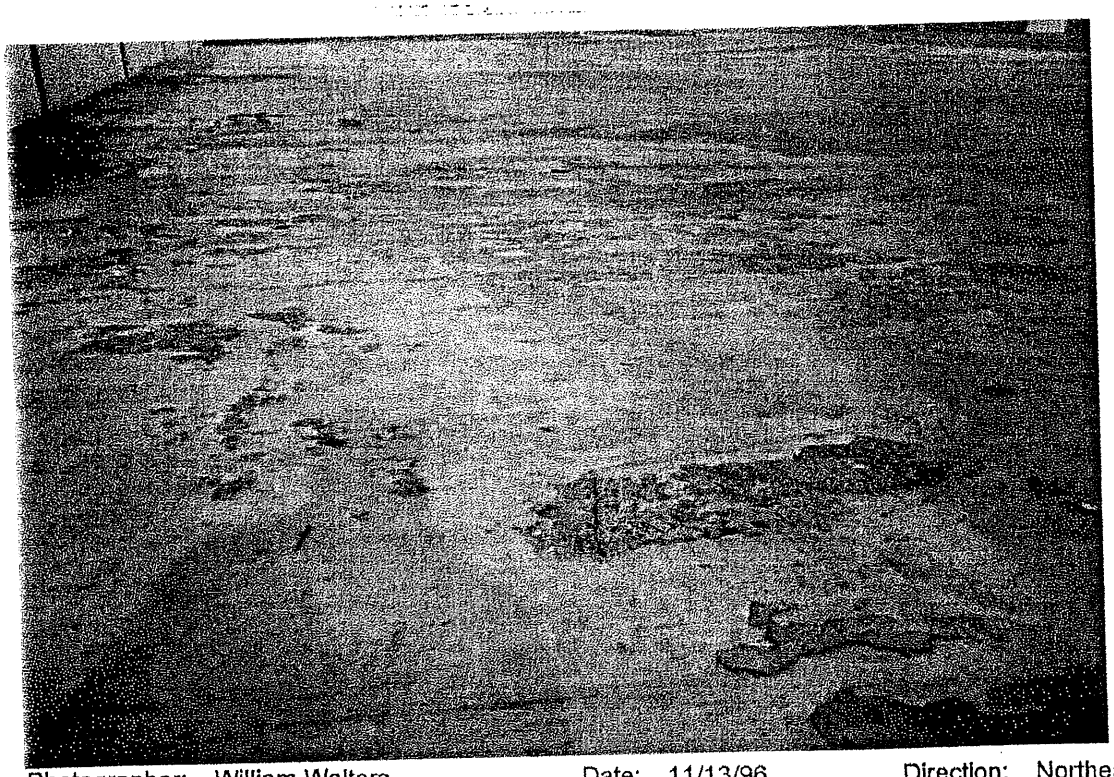
Description: Enamel-like material stuck to concrete on northwestern side of property.
