**HAZARDOUS MATERIALS REMOVAL WORK PLAN
BUILDING DEMOLITION
333 TURNBULL CANYON ROAD
CITY OF INDUSTRY, CALIFORNIA**

September 8, 2011
Project No. 100252002

Subject: Hazardous Materials Removal Work Plan
Building Demolition at
333 Turnbull Canyon Road
City of Industry, California

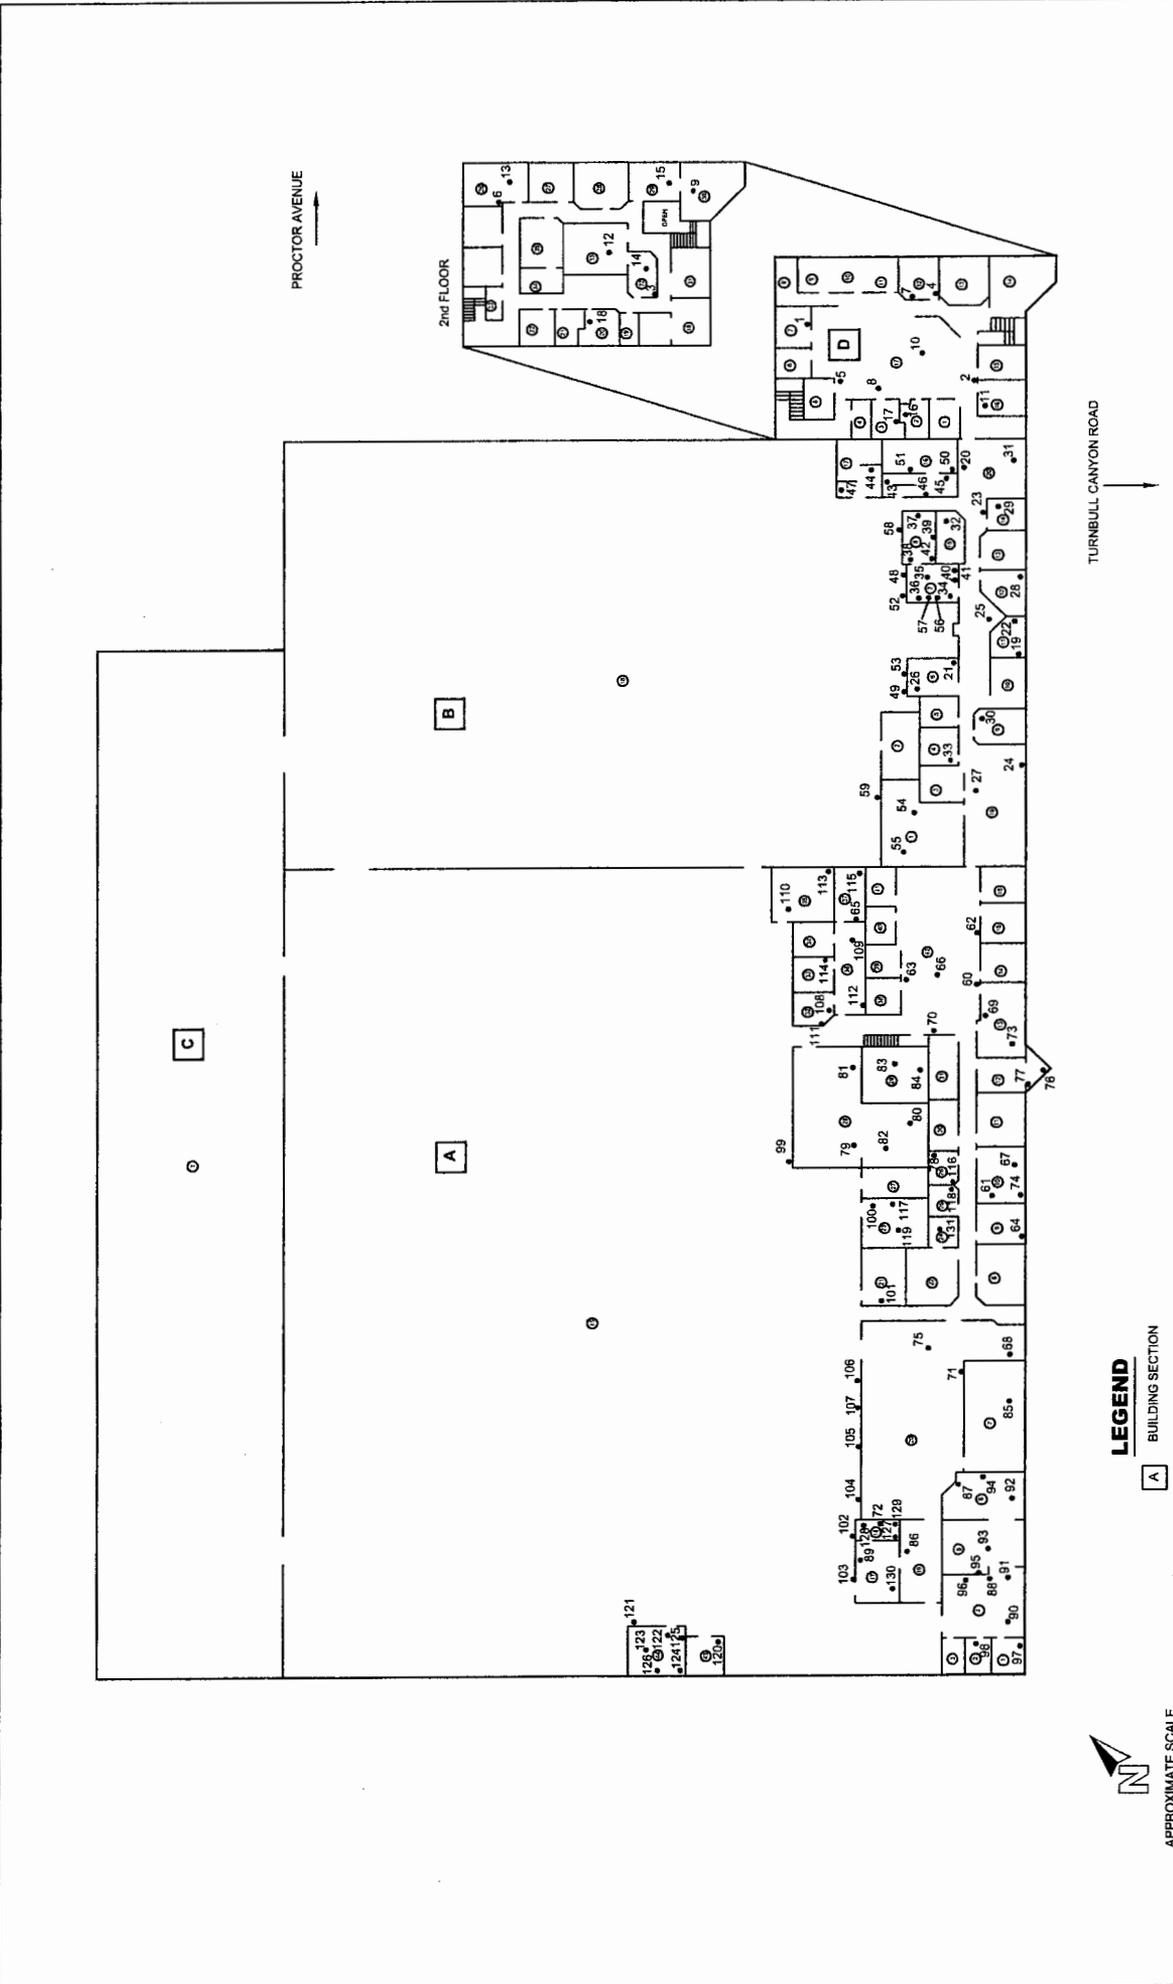
FIGURE **2**

Figure 2 – Sample Location Map

A listing of all homogeneous areas (HAs) of suspect ACMs is provided in Table 1. A total of 195 bulk samples were collected from the site buildings. Bulk sample descriptions are summarized in Table 2 and locations are shown in Figures 2 and 3.

HA = Homogeneous Area (see Table 1)
 sf = square feet
 Building and room number locations are shown in Figures 2 & 3

Note: Locations of buildings and room numbers are shown in Figures 2 and 3.

Notes:
HA = Homogeneous Area (see Table 1)
ND = Not Detected
Building, room, and sample locations are shown in Figures 2 & 3.
